MSC-07230

NATIONAL AERONAUTICS AND SPACE ADMINISTRATION

APOLLO 16 MISSION REPORT

MANNED SPACECRAFT CENTER
HOUSTON, TEXAS
AUGUST 1972

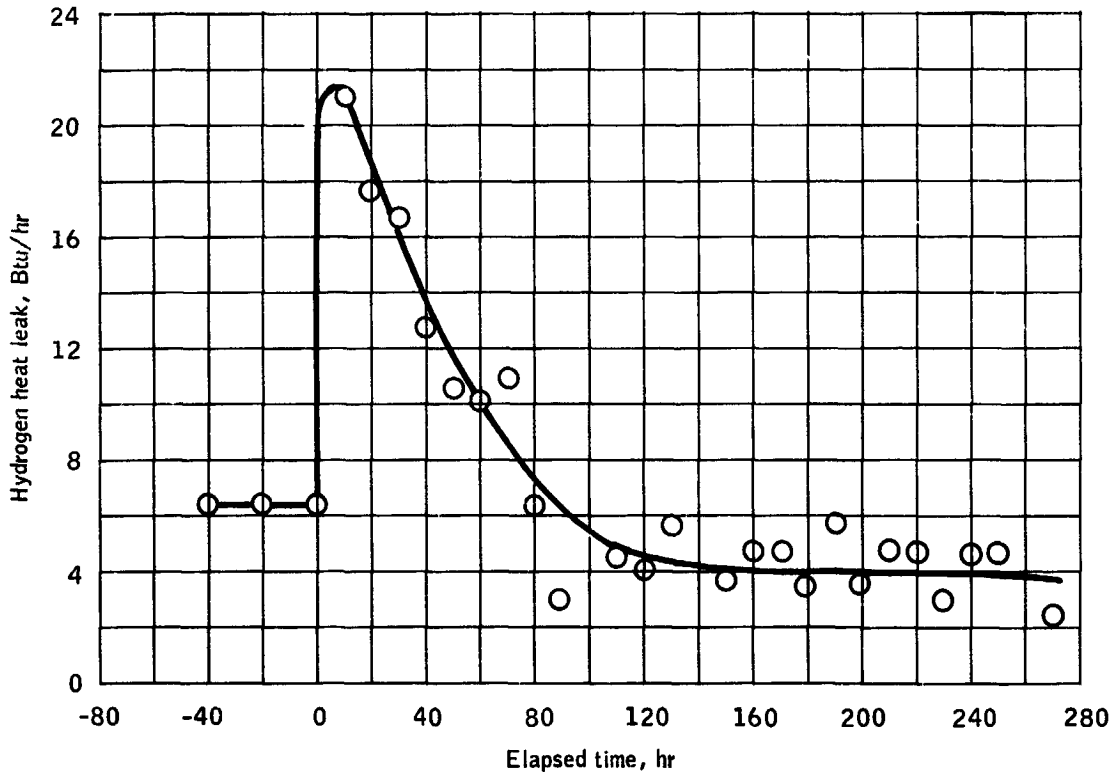
Figure 14-6.- Hydrogen tank heat leak data.

The heat leak into cryogenic hydrogen tank 3 was abnormal during the early hours of the mission. Analysis of the Kennedy Space Center data has shown that the heat leak of this tank was normal prior to lift-off. As shown in figure 14-6, the leak decreased from a high value of 15 to 20 Btu/hour to a normal 2 to 6 Btu/hour by 70 hours and remained normal thereafter. All other parameters were normal.

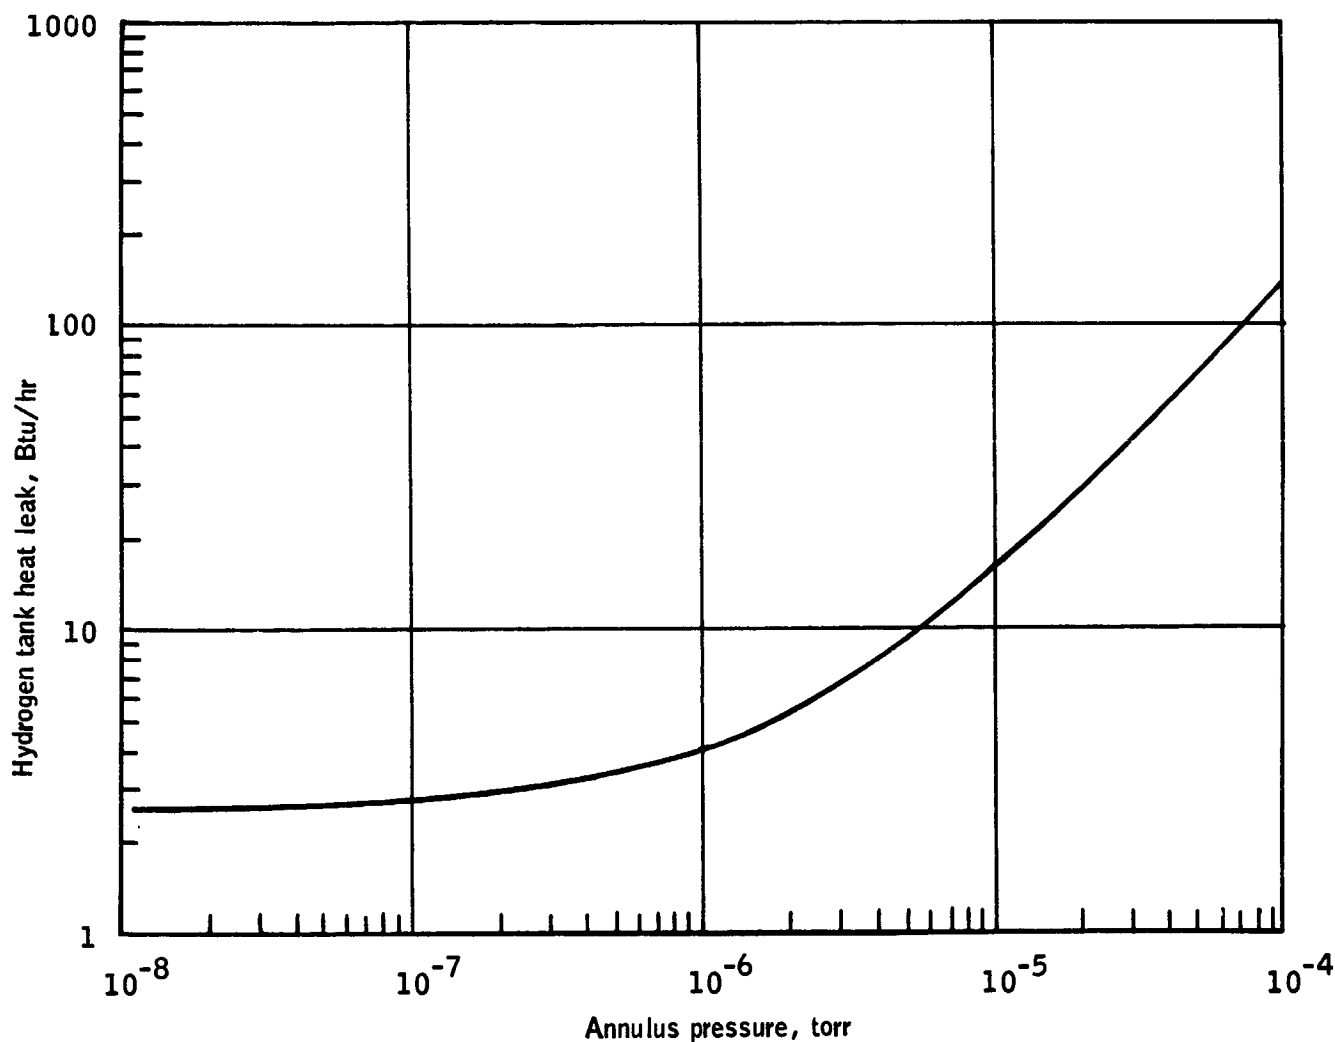
Figure 14-8.- Hydrogen tank heat leak as a function of annulus pressure.

Condition c.- An ambient air leak is the most probable cause of the high heat leak. Figure 14-8 shows that a pressure of 5×10^{-5} torr in the annulus would produce a heat leak of 21 Btu/hr, which is the average observed for the first 10 hours of the flight. The heat leak returned to a normal value of 6 Btu/hr by 80 hours, which corresponds to approximately 2×10^{-6} torr. Assuming that a small hole opened in the outer shell during the launch phase, the annulus pressure would quickly build up to that required to produce the observed heat leak. As the bay pressure continued to decrease and fall below that in the annulus, the annulus pressure would follow the decrease slowly and drop to a final value sufficient to provide the normal heat leak observed by 80 hours. Analysis shows that the area of the opening was at least 2.2×10^{-3} sq cm. For an opening of this size, iterative analysis places the formation of the crack or hole at approximately 2 1/2 minutes into the flight to produce the observed conditions.

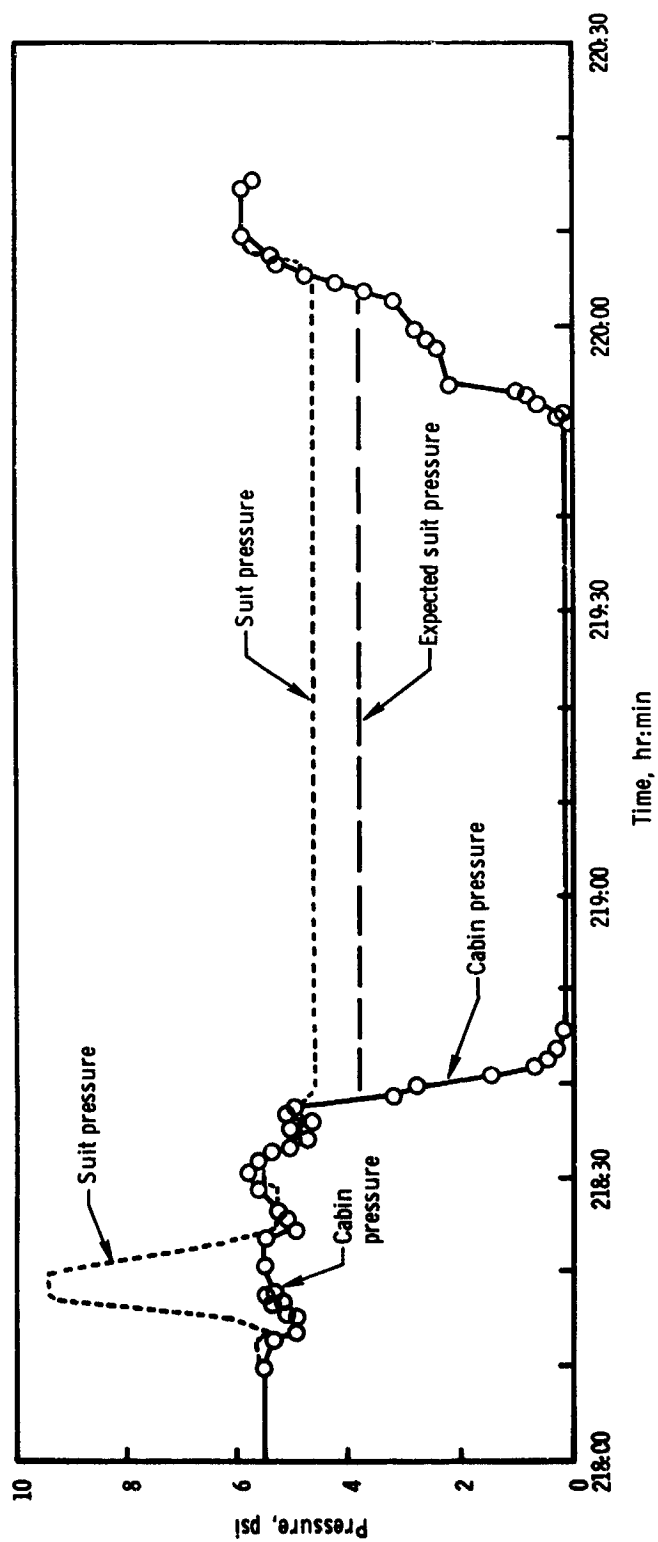
Figure 14-13.- Suit loop pressure data.

While the cabin was depressurized during the transearth extravehicular activity, the indicated environmental control system suit loop pressure transducer reading was 4.6 psia (fig. 14-13). Specification values for this regulated pressure are 3.5 to 4.0 psia and the control point determined from Kennedy Space Center altitude chamber testing was 3.8 psia. The Commander's and Lunar Module Pilot's suit cuff gage readings of 3.5 and 3.8 psia indicated that pressure regulation was satisfactory and that the transducer reading was erroneous.

Prior to the reduced cabin pressure operations, the suit transducer performed acceptably and read within 0.1 psi of the cabin pressure transducer with the suit loop open to cabin. After cabin repressurization, the suit transducer again appeared to read correctly above 4.6 psia.

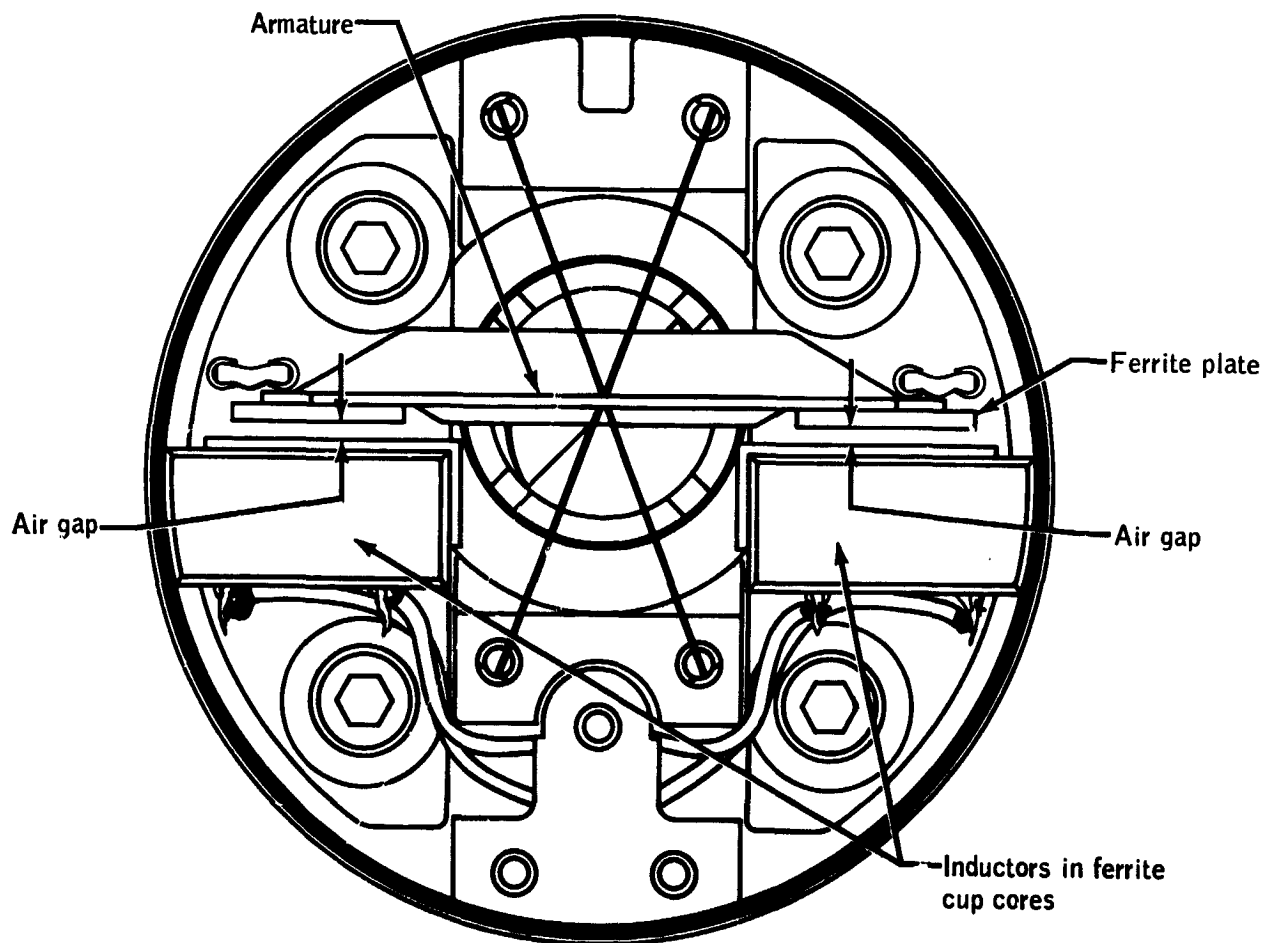
Figure 14-14.- Suit pressure transducer.

were conducted. The results were within tolerance. Teardown analysis revealed three particles of calcium aluminum silicate (lunar origin) ranging from 500 to 2000 microns in size in the sense cavity. If one of the lunar particles had been caught in the air gap (see fig. 14-14) of the variable reluctance element, the armature would transmit an incorrect signal. Normal readings were obtained when the cabin was repressurized and a suit pressure in excess of 4.6 psia was obtained. This could have freed any particle that might have been lodged in the air gap.

The corrective action for Apollo 17 and later spacecraft will be to add a 5-micron filter in the suit pressure sense line to protect the suit pressure transducer.

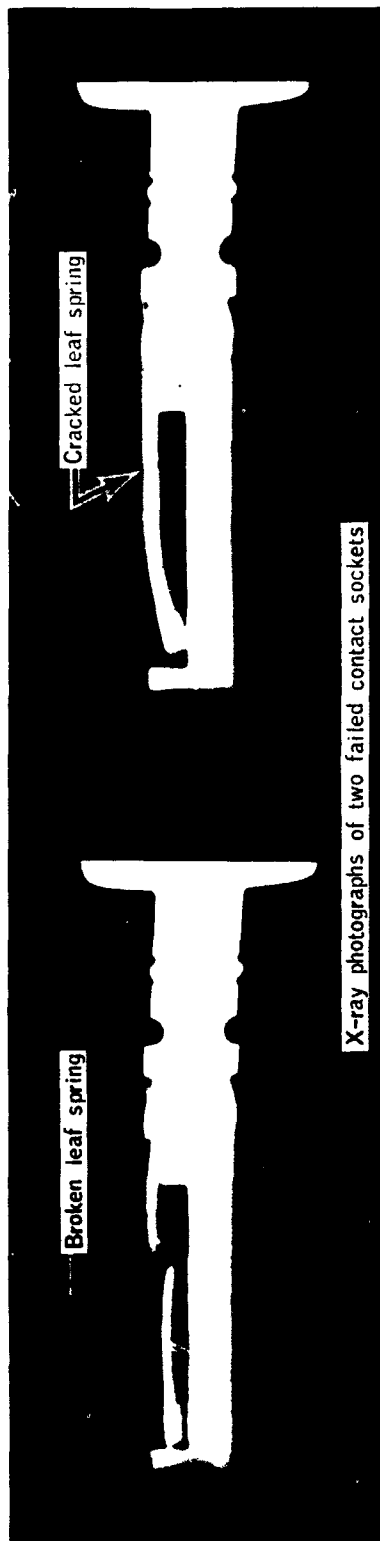
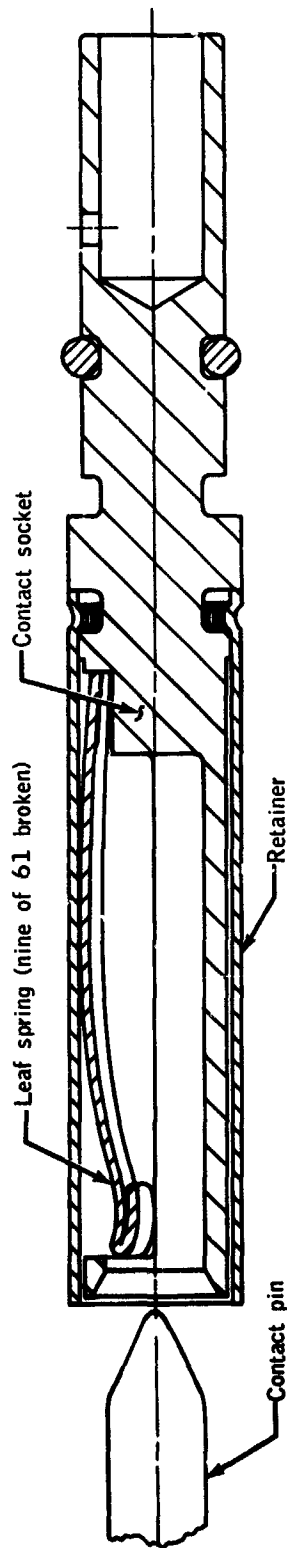
Figure 14-16.- Contact and leaf spring arrangement of optical unit connector.

The optical unit assembly was thoroughly soaked during recovery by salt water which caused extensive corrosion. The unit was cleaned, however, and tested. The intermittent flight condition was reproduced by wiggling the scanning telescope wiring harness in the optical unit assembly. An examination of the female connector on this harness revealed 9 of 61 contact springs (fig. 14-16) were cracked or broken. Also, several contact springs were found broken in a 91-pin connector in the optical unit assembly. The cause of the broken springs is being investigated.

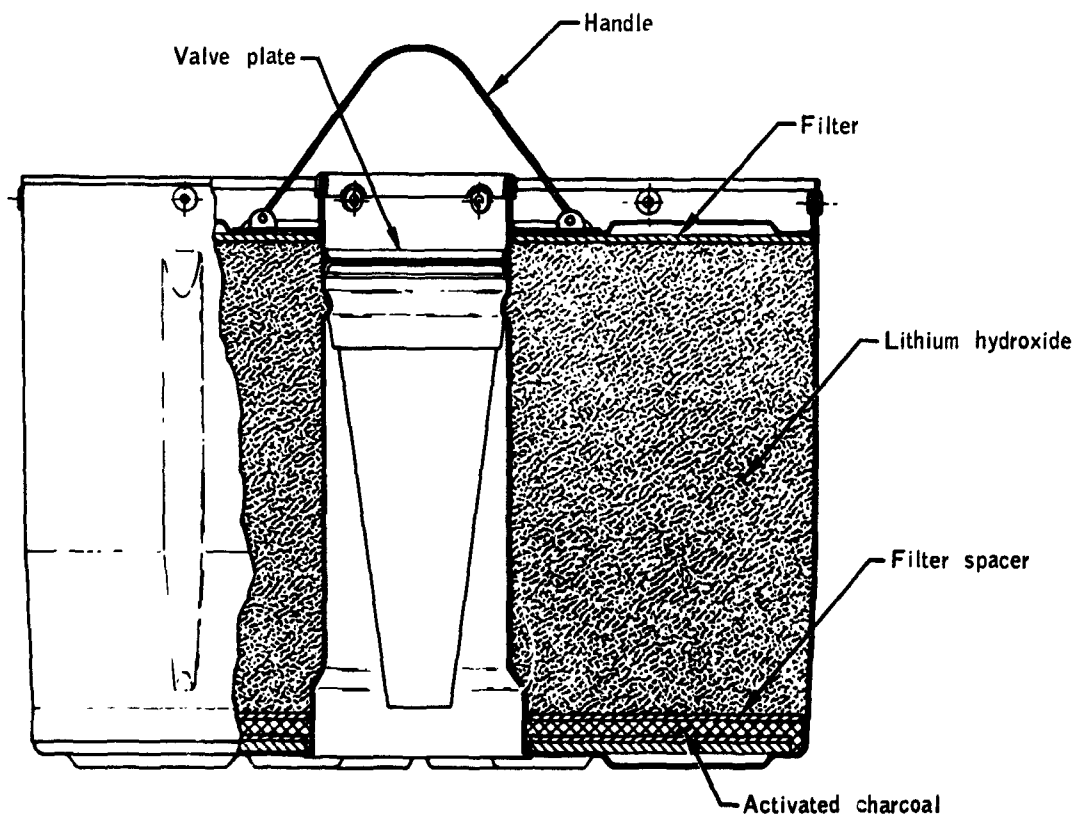
Figure 14-17.- Lithium hydroxide canister.

A dimensional analysis showed both sides of the environmental control unit canister receptacle to be within specification, although postflight removal forces using the canisters indicated a tighter fit in side B (53-lb pull) than side A (22-lb pull). The preflight pull force for this canister was 18 pounds. Normally, pull forces for these canisters are 10 pounds or less.

The combination of the adverse environment and the initially tighter-fitting canister apparently accounted for the removal difficulty.

To prevent recurrence of this problem during the Apollo 17 mission, the prelaunch insertion and removal force specification during fit checks at the Kennedy Space Center will be changed from 30 pounds to 8 pounds for the canisters to be used during the solo activities. The maximum allowable force on the remaining canisters will be reduced to 15 pounds. In addition, flight procedures will be changed to insure that the suit flow control valves are positioned to cabin flow for solo operation.

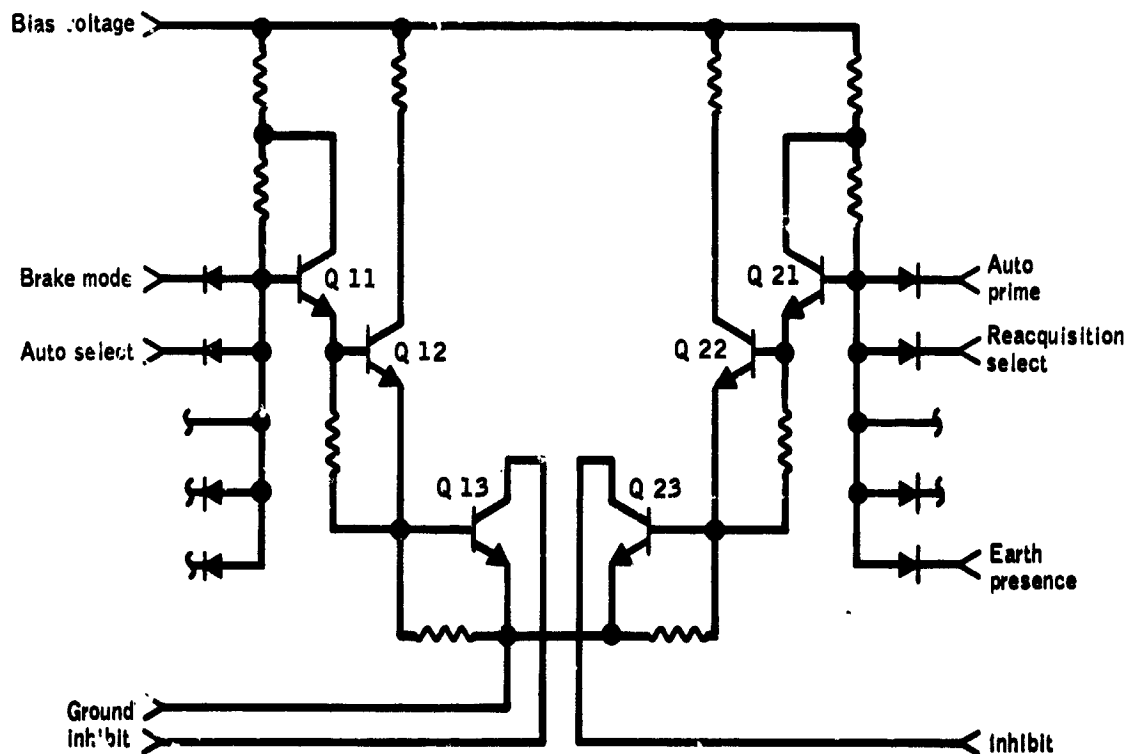
Figure 14-21.- Schematic of integrated circuit within uplink package.

The integrated circuit generating the inhibit is shown in figure 14-21. These types of devices have been found susceptible to contamination from internal floating particles. A particle can move as a result of acceleration or electric fields, and create an internal short which changes the state. Additional acceleration or changes in the electric fields can result in the particle moving again and either clearing the problem, or showing itself as an intermittent problem.

A particle resulting in any one of the following shorts (fig. 14-21) would result in an unscheduled inhibit.

No corrective action is planned because experience shows contamination in the electronics box has a low probability of occurring. Further, if the problem became permanent in one electronics box, the secondary unit can be selected.

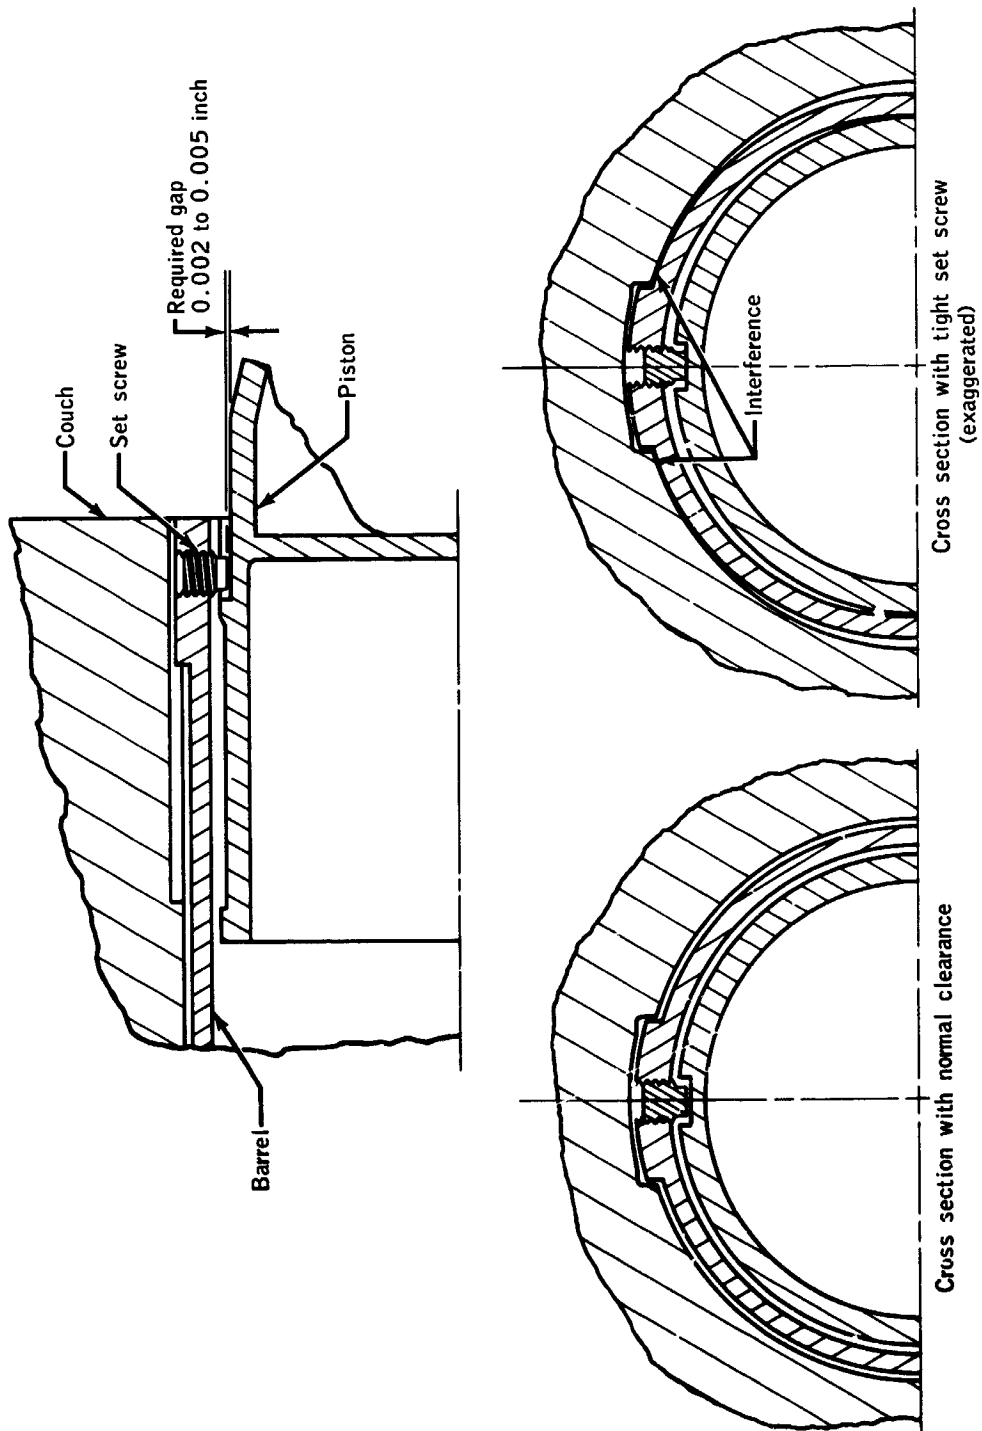
Figure 14-22.- Couch strut interference.

Postflight investigation showed no significant binding during strut operation. Visual examination (fig. 14-22) showed:

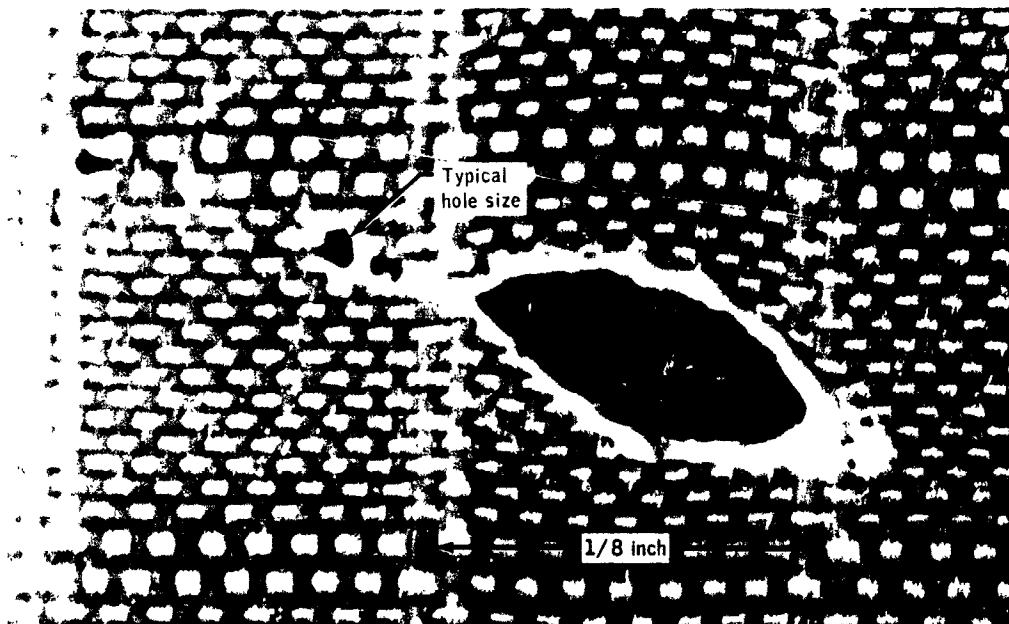
Figure 14-23.- Typical burn holes found in recovered parachutes.

Inspection of the canopy of one of the recovered main parachutes indicated numerous small burn holes which are similar to the burn holes observed on parachutes from previous missions (fig. 14-23). The cause of the earlier holes had been attributed to the reaction control system oxidizer.

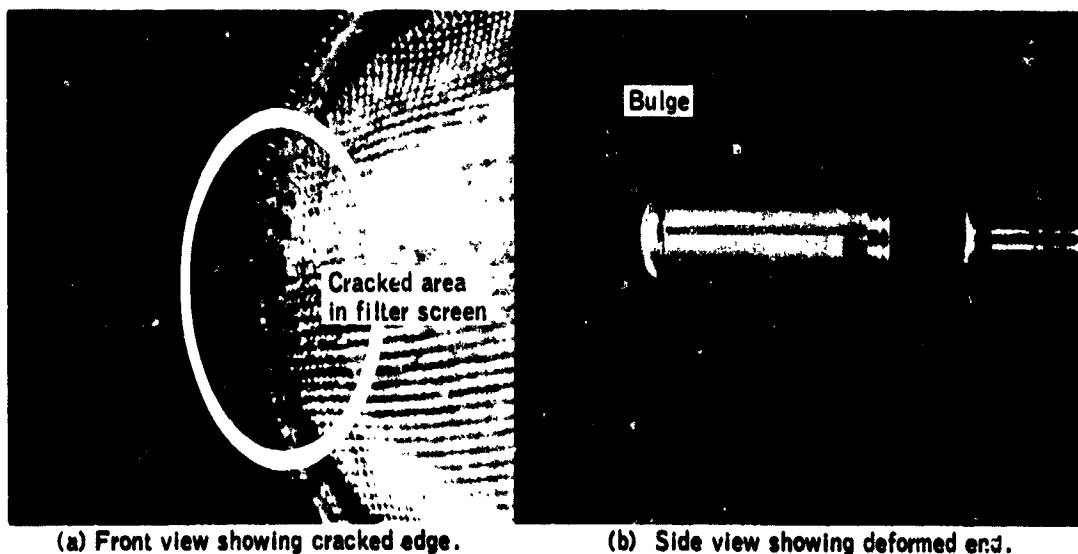
Figure 14-25.- Reaction control system regulator filter.

As a result of the Apollo 16 lunar module reaction control system regulator anomaly, the command module reaction control system regulators were removed for postflight testing and examination. A visual examination showed two of the regulator cylindrical-inlet-filter assemblies were deformed in the area of the end screen (fig. 14-25). On one filter, the end screen was bulged out about 0.060 inch. The visual examination also revealed that these two filters have either a wire separation or crack in the end screen near the peripheral weld area. Tests showed that the bubble point on the worst-case filter had increased to 100 microns (specification is 25 microns). The filters on the other two regulators were essentially normal, and testing on these two regulators showed completely normal characteristics.

The deformed filters are being evaluated. This evaluation includes retesting the filters for bubble point and performing a microscopic examination and a metallurgical examination in the areas of the wire separation. The objective of this investigation is to establish if the deformation is a normal condition resulting from system activation or if a unique condition occurred on Apollo 16.

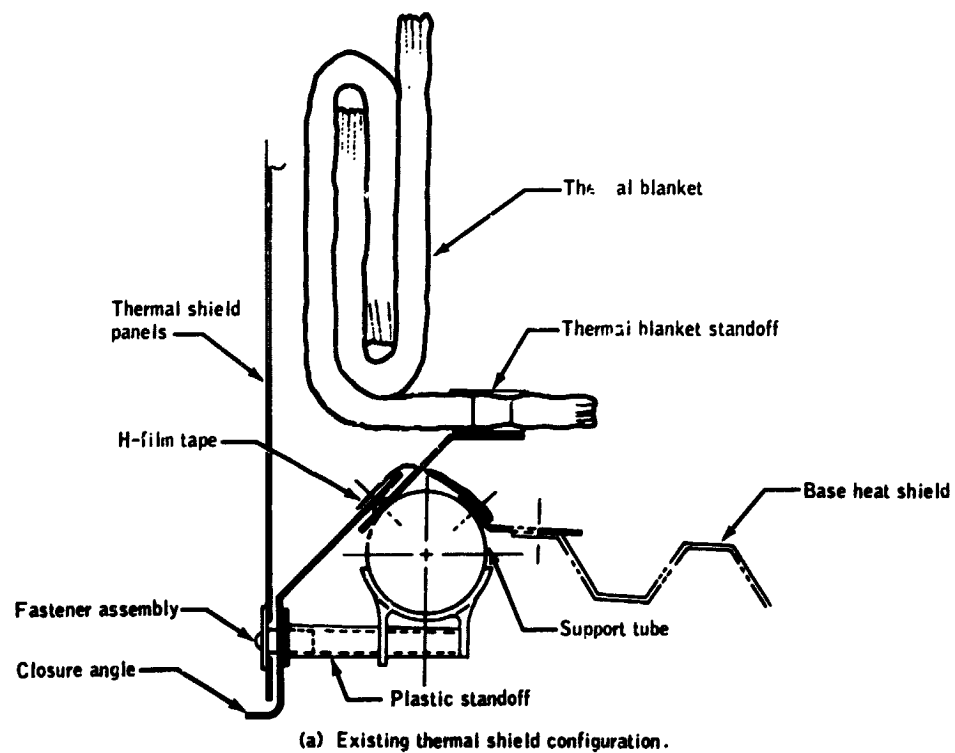
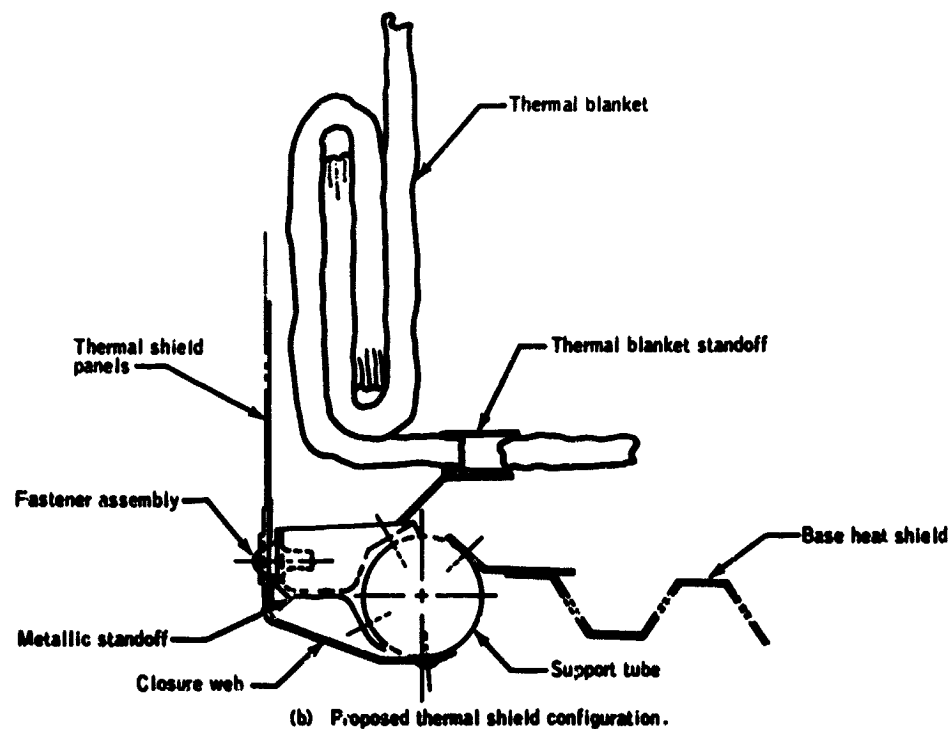
Figure 14-43.- Aft equipment rack thermal protection configuration.

The most probable cause of the failure was ascent engine exhaust entering the cavity behind these thermal shields. A cross section of the lower edge of the shields is shown in figure 14-27. Analysis shows that the thermal shield which extends below the support tube allows a pressure buildup on the closure shield which exceeds its capability. Once the closure shield failed, the exhaust entered the cavity behind the shield, resulting in a pressure buildup exceeding the capability of the vertical thermal shields. The detailed flight configuration in this area was not tested.

The corrective action will include a redesign of the thermal shield to eliminate the projection below the support tube, as shown in figure 14-27, and to provide additional venting to the blankets as well as additional standoffs.

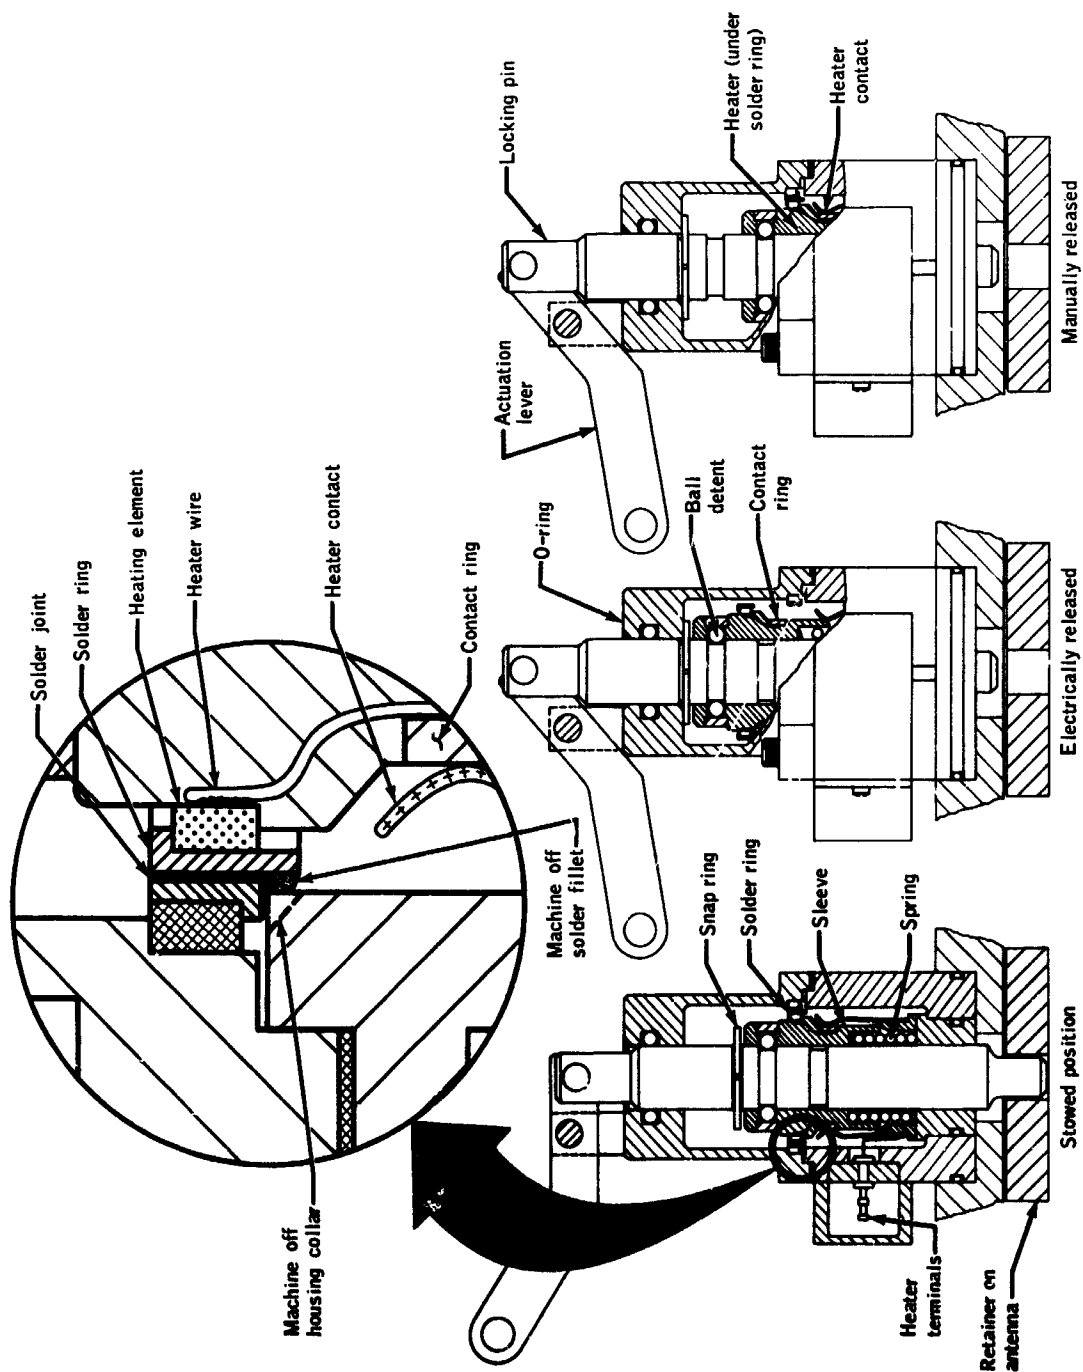
Figure 14-30.- Antenna stow latch mechanism.

Antenna photographs taken on the lunar surface and in lunar orbit prior to docking indicate that the lever for the yaw axis latch was still in the locked position. The crew noted a 2- to 3-degree movement of the yaw indicator during activation attempts. Ground tests have shown that the tolerances in the antenna retainer/locking mechanism will allow a slight movement of the antenna dish even though the pin is locked.

There are several areas in the electrical circuitry which could have caused the problem. One is that one contact in the safe/arm switch (figure 14-31) did not make. The second is that an open may have existed downstream of the safe/arm switch, either in the solder-melting element or in the wiring back through ground. A resistance measurement is made across the two parallel solder-melting elements prior to flight. About a 3-ohm increase in resistance was found at the last check. This change is equivalent to a possible 10-ohm increase in one of the elements which could have reduced the power dissipation below that required to melt the solder. Allowable tolerances on mechanical drawings and tests on sample latches have shown that it is possible for a solder fillet extending below the ring to make physical contact with the housing (fig. 14-30). The

contact allows the housing to act as a heat sink and, under marginal electrical conditions, draw off sufficient heat to prevent melting of the ring.

Several corrective actions are planned for Apollo 17 to cover all reasonable possibilities of failure. These include:

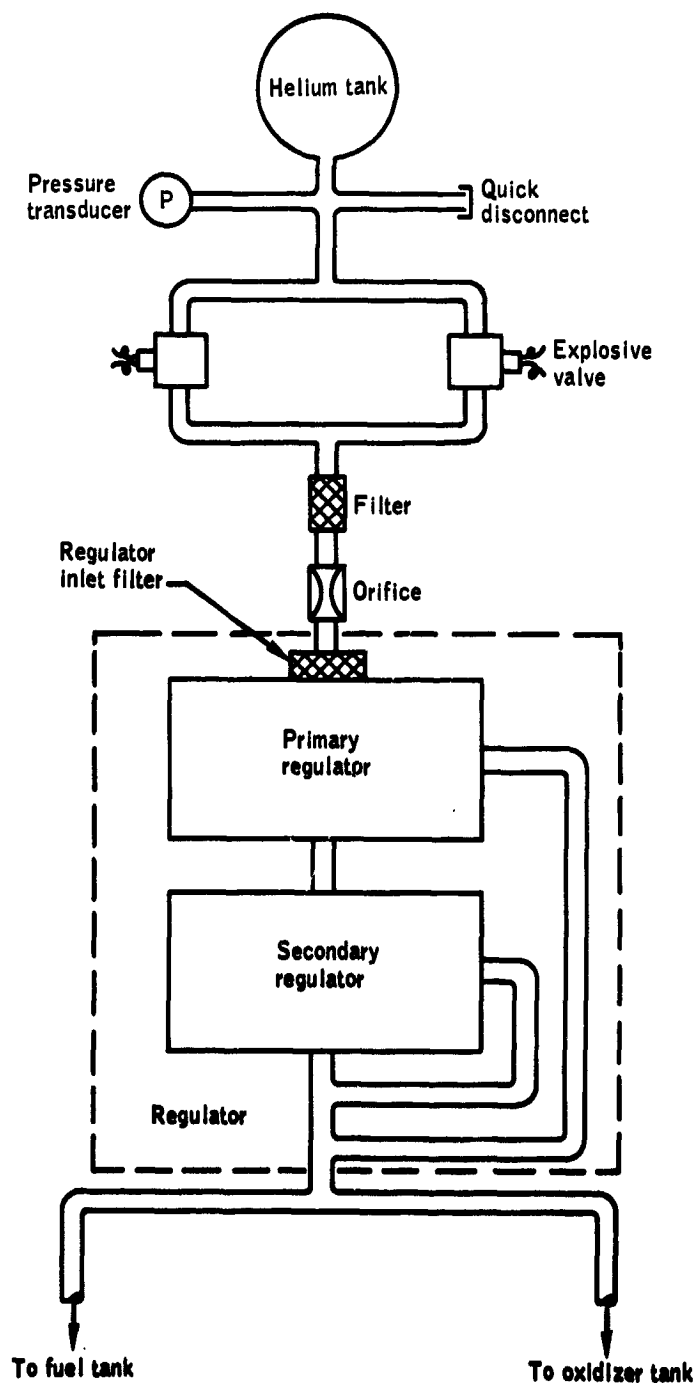
Figure 14-32.- Reaction control system pressurization system.

During pressurization of the system at about 95 hours, the regulator outlet pressure in system A (fig. 14-32) increased above regulator lockup pressure. The normal pressurization is characterized by a sharp increase from the nominal pad pressure, in the interval of 1 to 2 seconds, to the normal regulator outlet pressure. The outlet pressure of system A, after reaching the normal value of 184 psia, continued to rise at approximately 10 psi/minute, a condition which clearly indicated the existence of internal leakage in the regulator assembly.

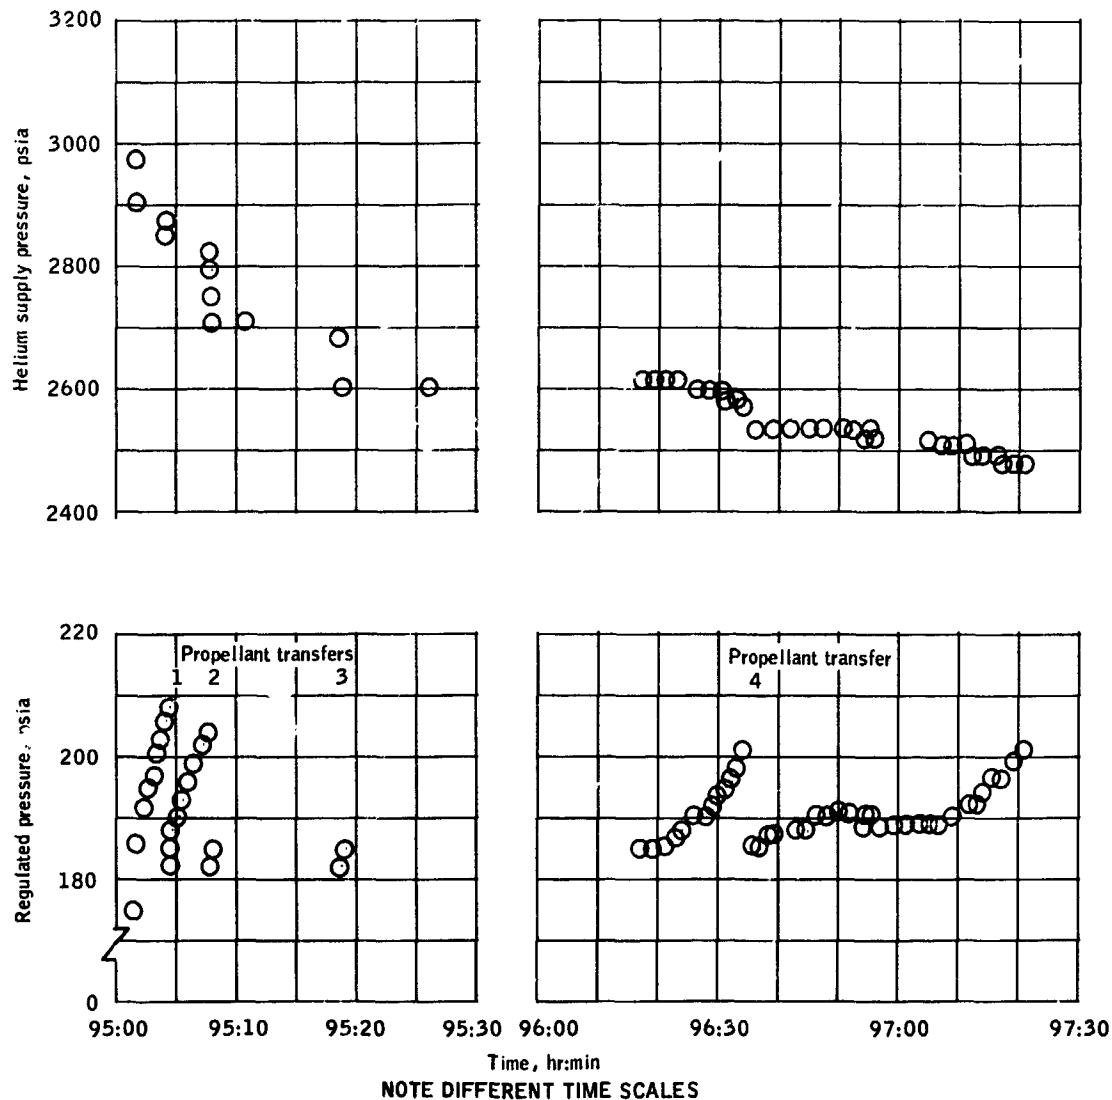
Figure 14-33.- Comparison of helium supply pressure and regulator outlet pressure following reaction control system pressurization.

Approximately 3 minutes after pressurization, the first of four propellant transfer operations was performed (fig. 14-33) to lower the ullage pressure and to create a larger pressurant volume in the propellant tanks, thereby obtaining a blowdown capability for expulsion of the remaining propellant in case of total loss of system A pressurization gas through the relief valves. The helium leakage continued throughout the mission, although the leakage rate varied from essentially zero to a maximum of about 1100 scc/min (figs. 14-34 and 14-35). The regulator outlet pressure eventually increased to about 237 psia at which time the relief valves of system A started to periodically relieve the pressure to about 232 psia.

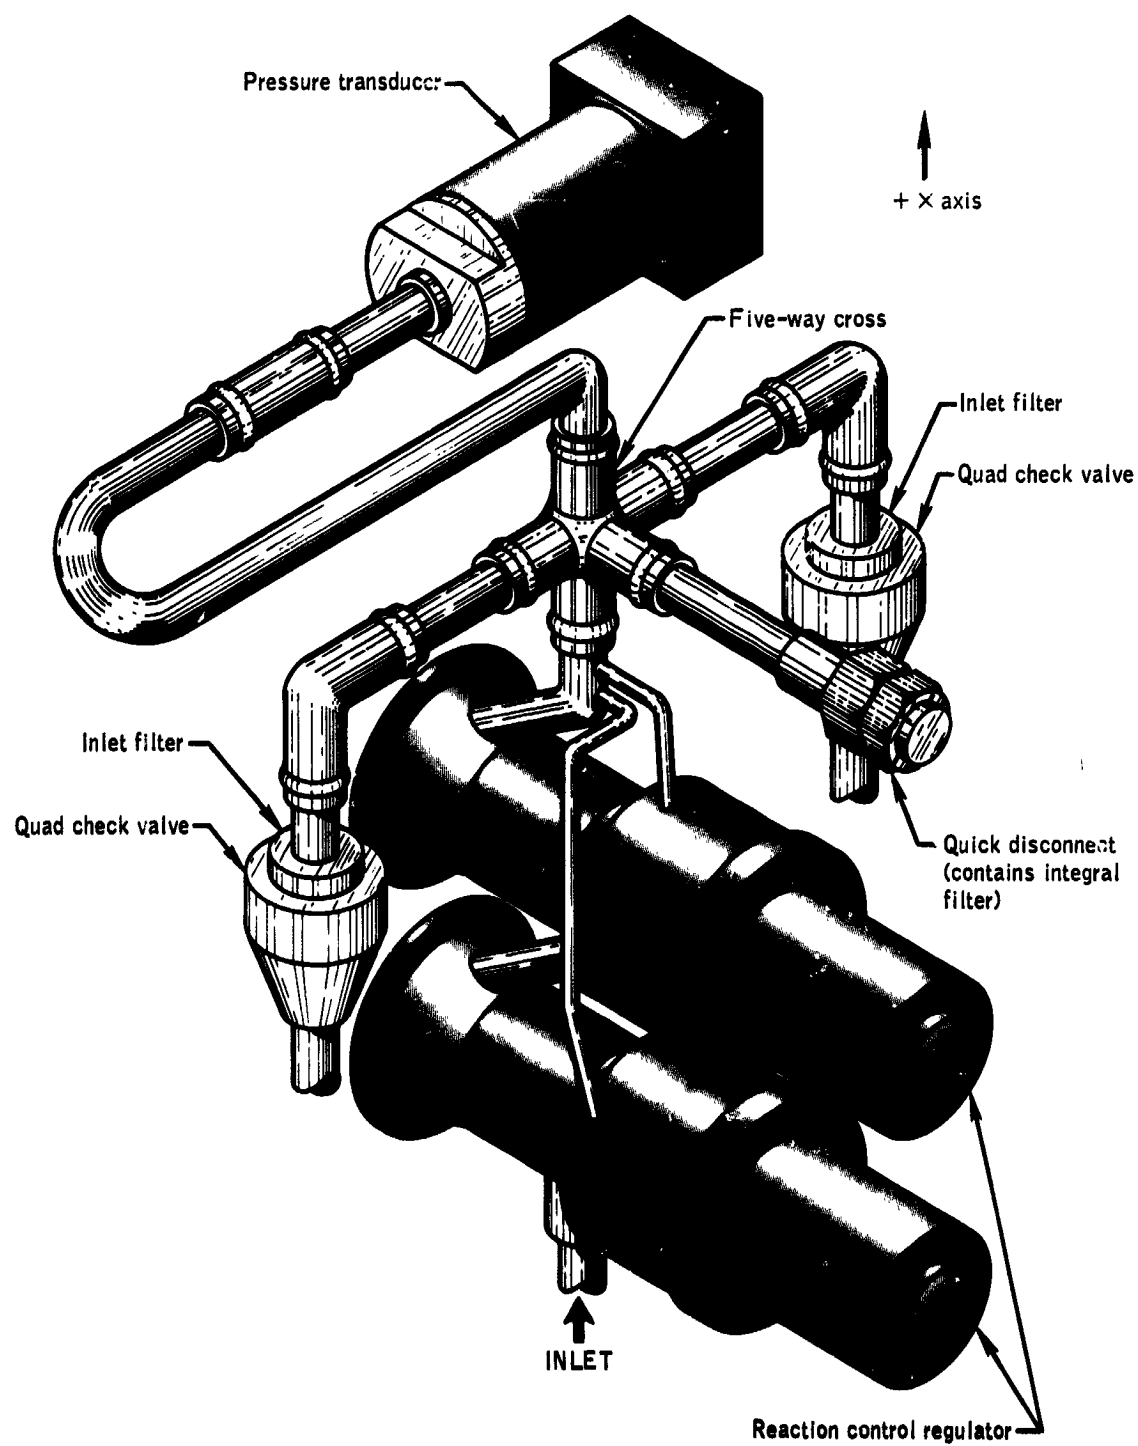
Figure 14-37.- Repaired reaction control system module area.

During buildup of the Apollo 16 reaction control system module, a quick disconnect (fig. 14-37) located directly downstream of the regulator outlet was replaced three times. During one change a five-legged fitting (fig. 14-37) required replacement. The repairs required seven brazing operations in an area which is directly above the regulator outlet when installed in the vehicle. Any contaminants introduced during these operations would be trapped in the volume downstream of the regulator by various filters (fig. 14-37). These contaminants could have been moved around during reaction control system module installation or when the lunar module ascent stage was rotated during the cleaning process. During these operations, any contaminants present could have been transported to the area directly downstream of the secondary regulator primary poppet. This volume has many areas where contaminants can be trapped (fig. 14-36).

The most probable cause of the leakage is contamination introduced during component replacement and, subsequently, swept into the regulator outlet by backflow. There is also the possibility that lubricant existed on the sealing surfaces to capture the contaminants.

No components have been replaced downstream of the Apollo 17 lunar module regulators. Also, the following changes will be made to the launch site testing to eliminate regulator backflow.

a. A quad check valve cracking test will be performed by pressurizing through the quick disconnect upstream of the regulator rather than downstream.

b. A caution and warning limits test will be performed prior to the regulator functional test and with the secondary regulator locked up.

c. A test will be added to assure that the secondary regulator poppets seat at low differential pressures.

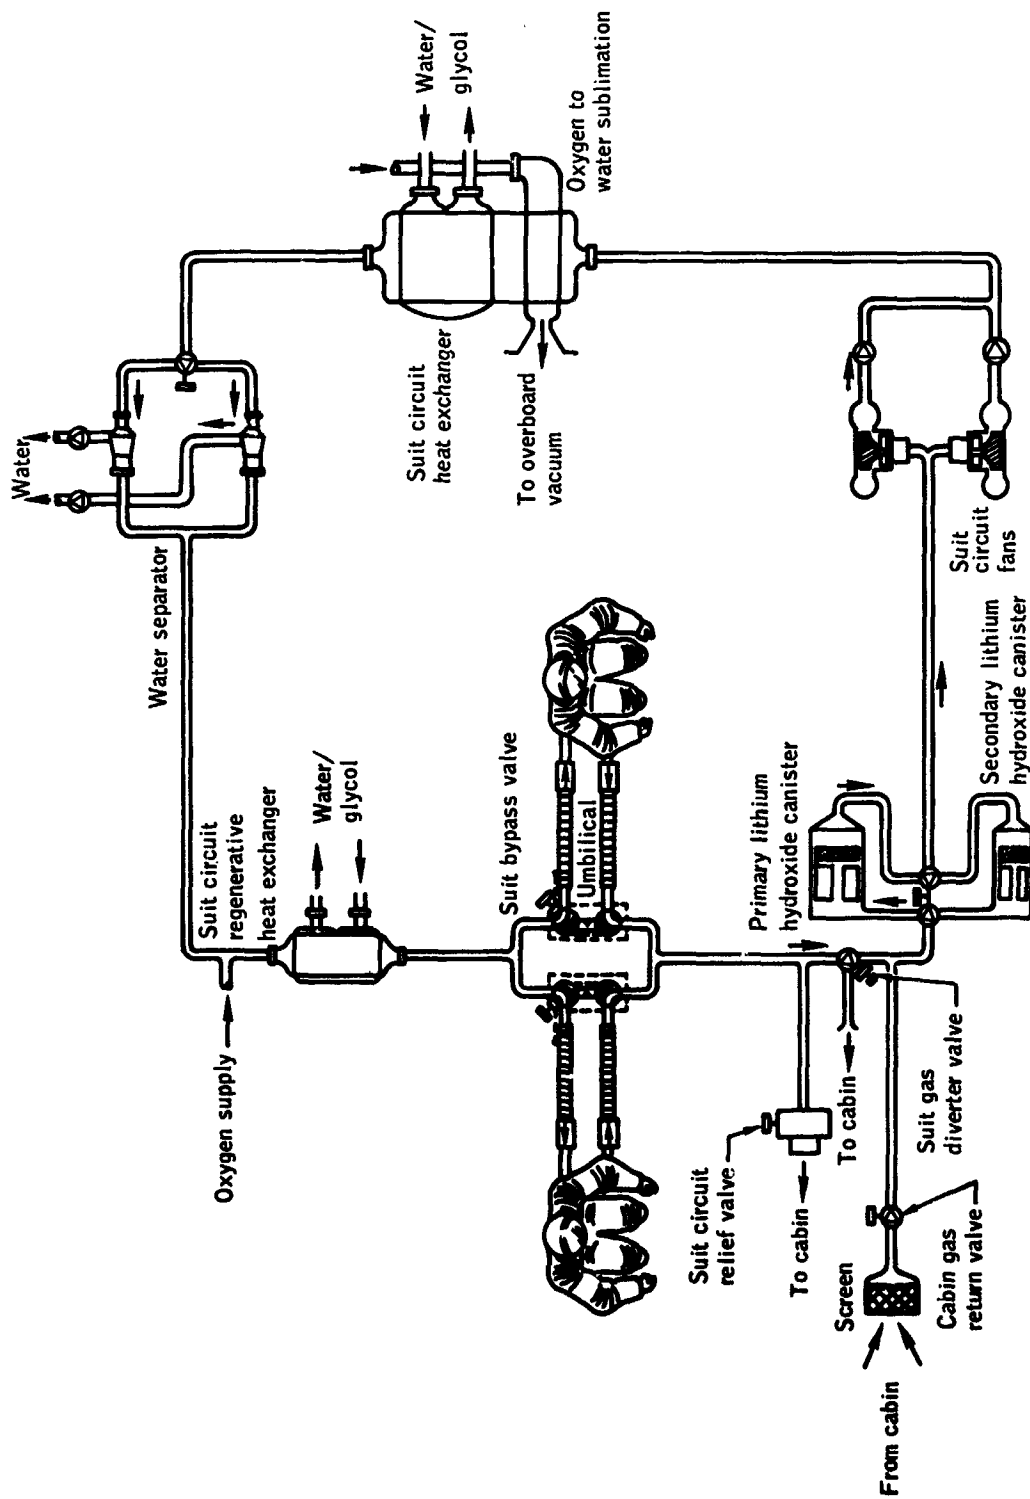
Figure 14-38.- Atmosphere revitalization section.

The crew reported hearing a chattering noise and experiencing a pulsating, insufficient flow in the suit circuit at 95:47 while configured to the cabin mode of operation (fig. 14-38). Data indicate that the cabin mode flow was normal at system activation (93:41), and this was confirmed by the crew after the mission. The pulsing and chattering occurred again after the demand regulator check (95:55) and after lunar landing (105:57).

The problem was traced to the cabin gas return valve which apparently failed to open in the "automatic" position, thus blocking the cabin gas from returning to the suit circuit. This results in "deadheading" of the suit fan, thereby causing the downstream check valve to chatter and pulsate due to the small amount of flow drawn through the suit gas diverter valve in the cabin position. The manual "open" and "closed" positions of the cabin gas return valve were used for the remainder of the mission. The "automatic" position was selected later during the lunar stay and operated normally (good flow, no chatter).
